Metallurgical Examination of a Failed Automotive Helical Suspension Spring

Report Number: Y1234

**Danie Els
22nd November 2024**

LPD Lab Services Limited

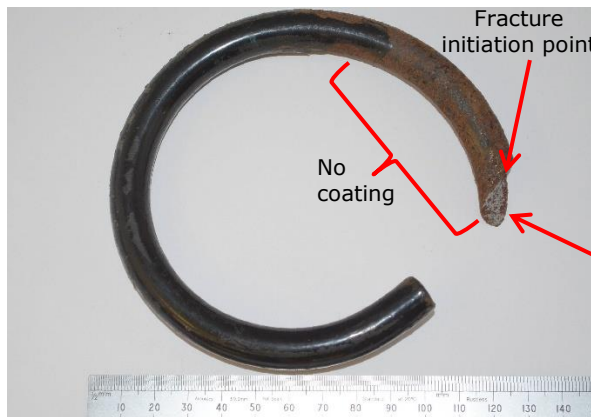
The received sample of the fractured spring is shown from two sides in Figure 1 and Figure 2, respectively. Fracture occurred almost one revolution away from the end of the coil and the fracture initiation point was orientated toward the end of the coil. The fracture face was orientated at 45° to the axis of the spring wire, which is typical of fracture in torsion.

Figure 1. The received portion of the failed helical spring.

All of the protective polymer coating was lost at the location of the fracture; up to about 9cm away from the fracture face, as indicated in the above images. The exposed steel surface had suffered a significant level of corrosion, having been exposed to spray water from salted road surfaces for a long time. Furthermore, the corrosion had propagated along the interface between the protective coating and the steel, pushing the coating away from the steel as it progressed, as shown in Figure 3. Corrosion products have a larger volume than the metal consumed in the corrosion process. The corrosion products will, therefore, push the coating outward, away from the metal surface. This action is termed corrosion jacking and can cause a coating to crack if it does not have sufficient elasticity.

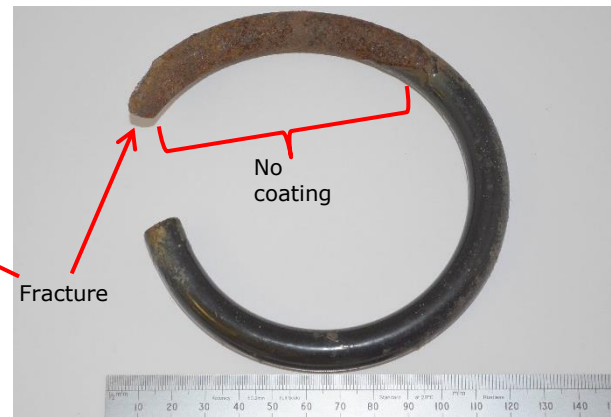
Figure 2. The opposite side to that shown in Figure 1.

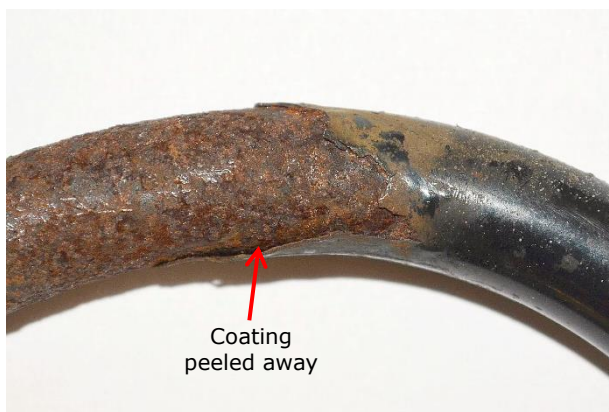
Figure 3. Corrosion progressed along the interface between the coating and the steel.

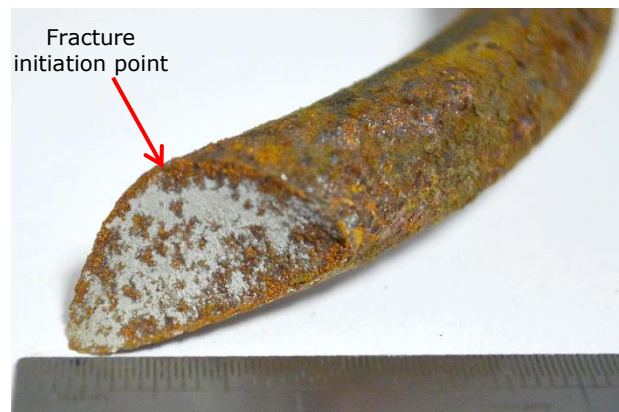
Figure 4. The fracture face with the location of the initiation point indicated.

The fracture face suffered a significant level of corrosion after the failure had occurred. The reason for this was because the failure was discovered some time after it had occurred. Fortunately, the corrosive attack on the fracture face was patchy, leaving sufficient fractographic evidence for interpretation. Radial propagation lines on the fracture face confirmed that fracture initiated at the external surface, on the centreline radius (halfway between the outer curve and the inner curve of the helix), as indicated in Figure 1 and Figure 4.

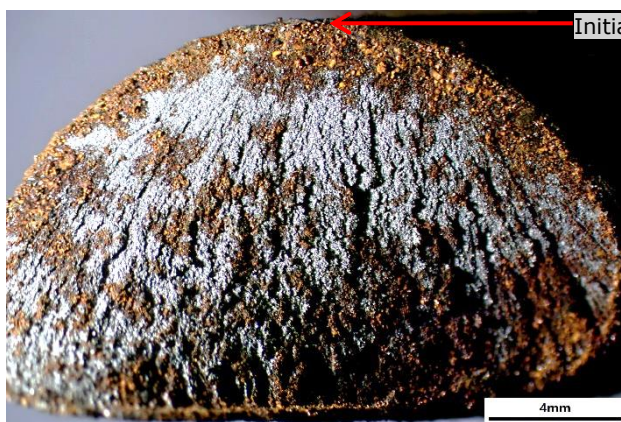
A low magnification optical image of the fracture face is shown in Figure 5, with the fracture initiation point positioned at the top of the image. The fracture initiation point is shown at higher magnification in Figure 6. Unfortunately, all fractographic detail at the location of fracture initiation was spoiled by corrosion and the presence or absence of fatigue cracking could not be confirmed.

Figure 5. The fracture face illuminated from the side to accentuate the fractographic features.

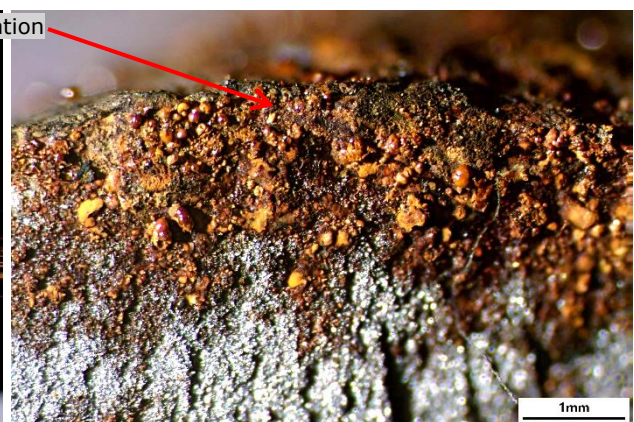
Figure 6. The region of fracture initiation, spoiled by corrosion.

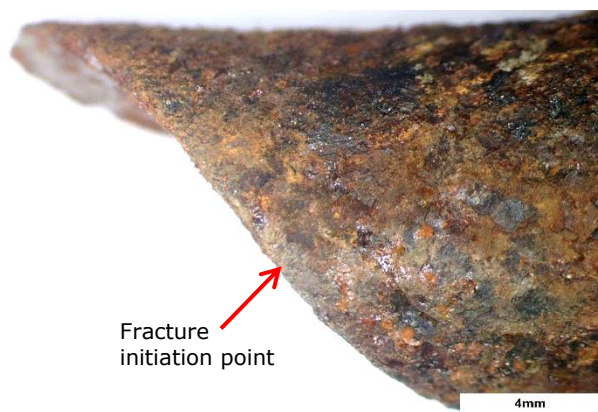
The external surface at the fracture initiation zone is shown in Figure 7. Due to damage caused by corrosion and because of the hindrance caused by the corrosion products, no evidence of a surface defect or surface irregularity that could have contributed to the fracture, could be observed on the external surface at the fracture initiation point. Figure 8 shows how the protective coating was lifted away from the spring surface.

Figure 7. Fracture initiated at the bottom of the spring and propagated at an angle of 45° to the main axis of the spring wire.

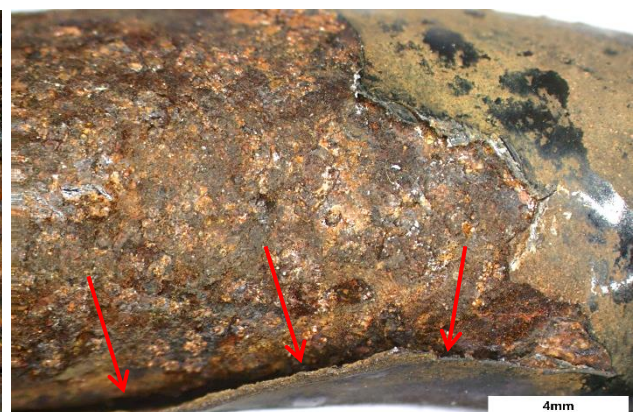
Figure 8. Corrosion progressed along the interface between the coating and the steel, peeling the coating off the spring.

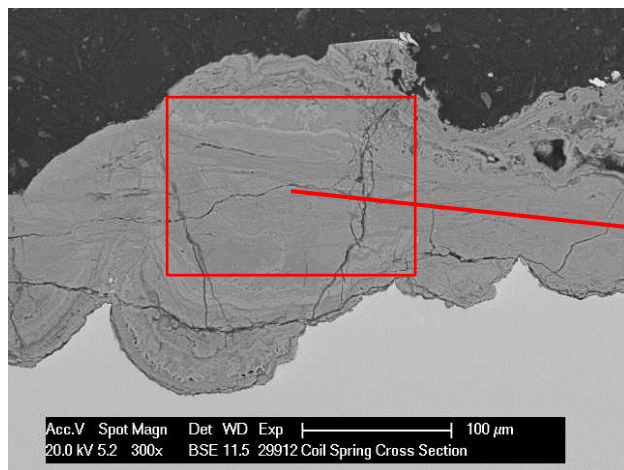
The corrosion products on the external surface of the metallographically prepared cross-section from adjacent to the fracture face were analysed by EDX spectroscopy, in the polished condition (not chemically etched). Figure 9 shows a backscattered electron (BSE) image of the analysis location whilst Figure 10 shows the EDX spectra and extracted composition of the corrosion products.

Figure 9. BSE image at the surface of the cross-section taken behind the fracture face.

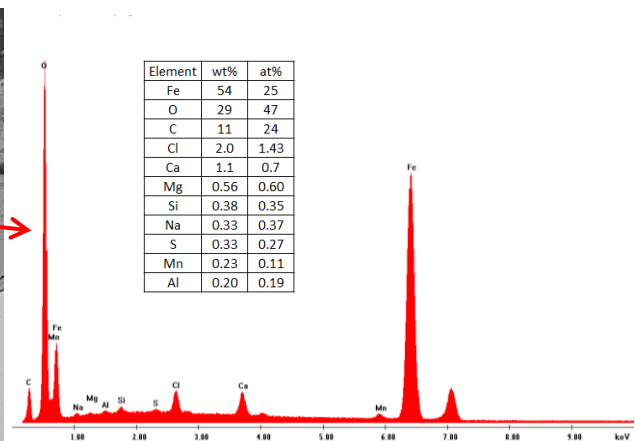
Figure 10. EDX spectrum and composition of the corrosion products at the external surface.

The elements in the corrosion products strongly suggested corrosion by spray water from salted roads. The chlorine and sulphur would typically have originated from rock salt use for de-icing British roads in winter.

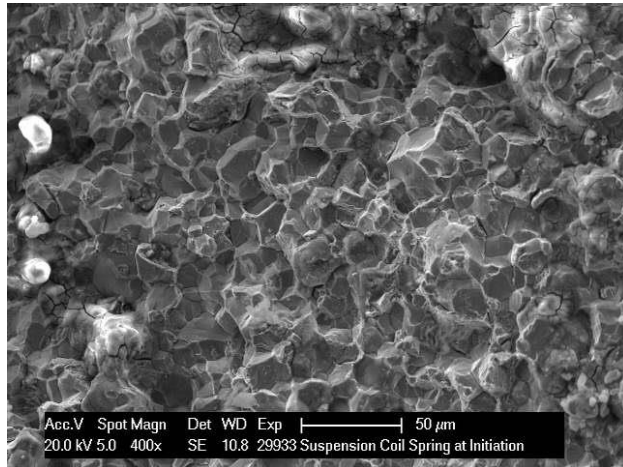
A secondary electron (SE) image of an area of the fracture face just next to the corrosion products on the region of fracture initiation is shown in Figure 11 and a higher magnification SE image of the same area is shown in Figure 12. Fracture propagated entirely in a brittle, intergranular manner at this location. The fractographic features suggested hydrogen embrittlement cracking. There was no evidence of striation marks to confirm any action of fatigue cracking.

Figure 11. A lower magnification SE image of the fracture face just next to the corrosion products at the fracture initiation area.

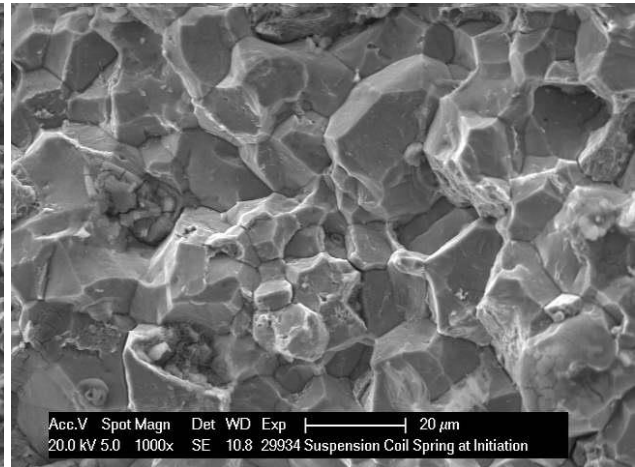
Figure 12. A higher magnification SE image of Figure 11 showing intergranular failure.

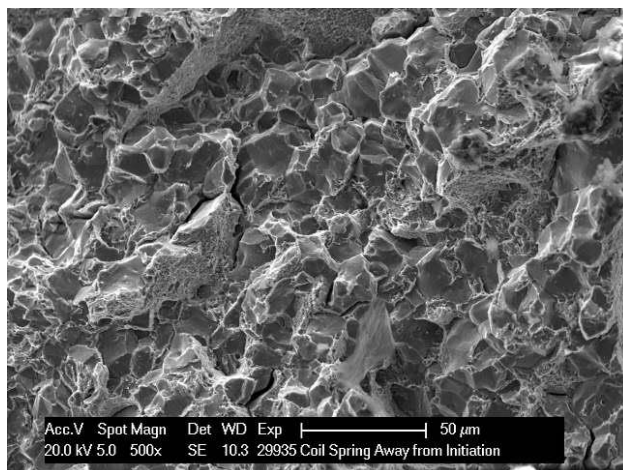
A secondary electron (SE) image of an area in the middle of the fracture is shown in Figure 13. Here, fracture mostly took place by micro-void coalescence (forming ductile dimples) and quasi-cleavage, as shown at higher magnification in Figure 14. Both are ductile failure mechanisms. There was also, however, evidence of brittle intergranular fracture and secondary cracking, as shown in Figure 15. This mixture of fracture mechanisms was due to the a significantly reduced hydrogen concentration away from the surface from where it would have diffused into the steel.

Figure 13. A lower magnification SE image of an area in the middle of the fracture face.

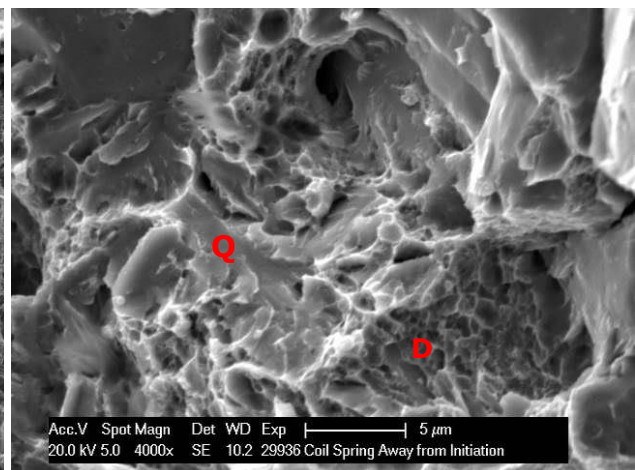
Figure 14. A higher magnification SE image of Figure 13 showing evidence of quasi-cleavage (Q) and ductile dimples (D).

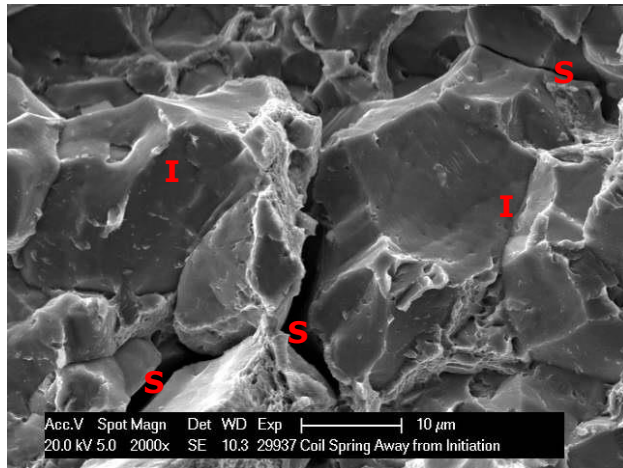
Figure 15. A higher magnification SE image of Figure 13 showing intergranular cracking (I) and secondary cracking (S).

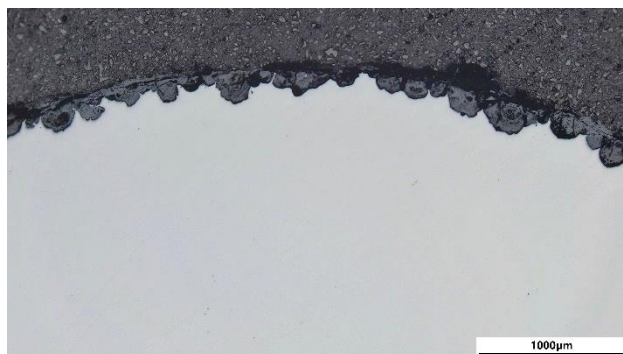
Examination of the metallographically polished section taken from behind the fracture face revealed that the entire external surface was affected by pitting corrosion, as showed in Figure 16. Some of the pits were as deep as 251 μm, as shown in Figure 17. These corrosion pits act as stress raisers that can facilitate the initiation cracks. There was no evidence of manufacturing defects (e.g., seams or laps).

Figure 16. Optical image of the surface of the section taken from behind the fracture face.

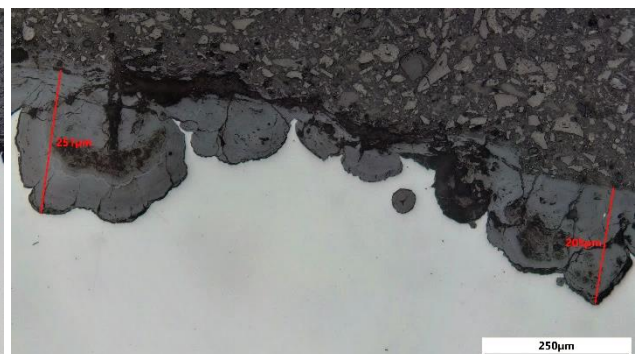
Figure 17. A higher magnification optical image of the pitting corrosion on the external surface.

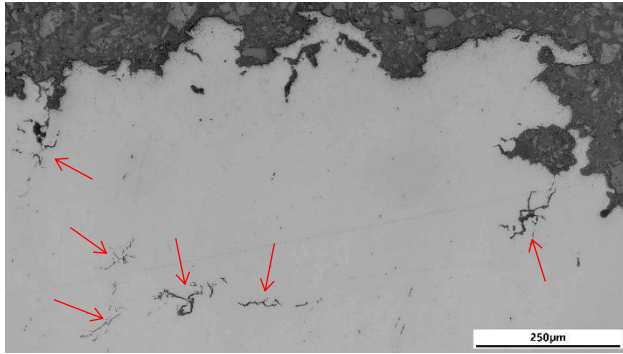
Examination of the polished section taken through the fracture initiation area revealed numerous internal cracks at and near the fracture face, as shown in Figure 18. This typically was hydrogen induced cracking (HIC).

Figure 18. Hydrogen stress cracks at middle of fracture face, indicated by arrows.

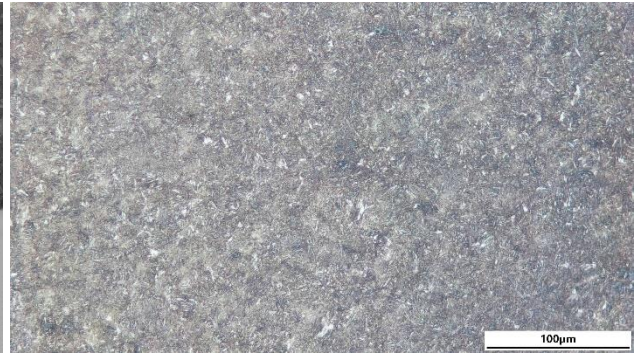
Examination of the etched section revealed that the material was in the quenched and tempered condition with a microstructure consisting of fine tempered martensite, as shown in Figure 19. There was no evidence of decarburisation, excessive non-metallic inclusions or defects.

Figure 19. Microstructure of the polished and etched spring material.
