# Metallurgical Examination of Jigsaw Blades for Cutting Aluminium alloy

**Report Number: Y1235**

**Danie Els  
7<sup>th</sup> November 2024**

## **LPD Lab Services Limited**

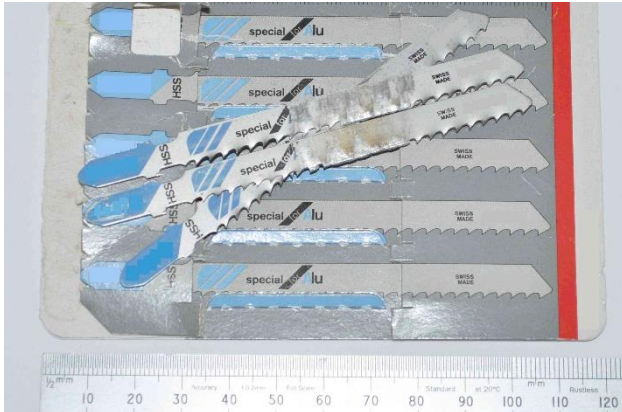
The jigsaw blades received for examination are shown in Figure 1, and a closer view of the affected areas on the blades are shown in Figure 2. The middle third of the teeth on each blade was encased in a layer of smeared aluminium alloy adhering to the teeth.

**Figure 1. The received jigsaw blades.**

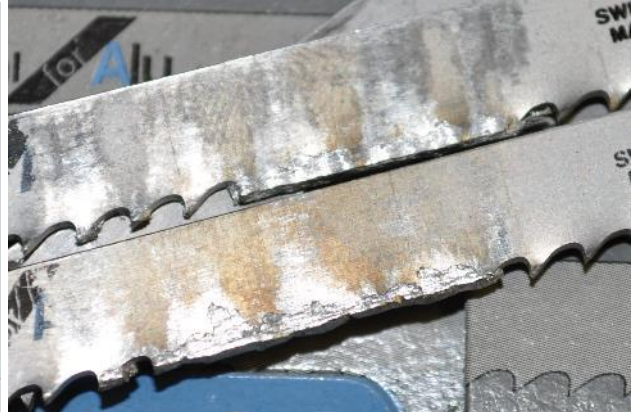
**Figure 2. The affected areas of the jigsaw blades.**

The cause of the difficulty to cut the plate was the softness of the new aluminium alloy plate which required a different approach, compared to the usual harder aluminium alloy, for hassle free cutting.

Firstly, it would be prudent to ensure that the procured aluminium alloy sheet, which was softer than usual, was in fact the correct material.

Secondly, when cutting soft aluminium alloy, there are two additional steps to be taken in order to facilitate the cutting process:

- Use a lubricant, like WD-40 or 3-in-1 oil, to help prevent the aluminium alloy from adhering to the blade and to reduce friction.
- Try to cut at a faster speed (i.e. the rate going forward) to reduce the heat created by friction between the blade and the aluminium alloy plate (caused by the oscillating motion of the blade).

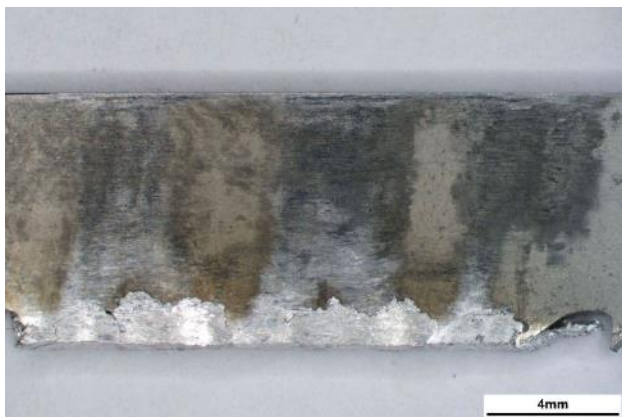
Magnified optical examination of the affected areas on the blades confirmed that the teeth were encased in deformed aluminium alloy, as shown in Figure 3 and at higher magnification in Figure 4. This clogging of the teeth would have made it impossible for the blades to cut.

**Figure 3. A lower magnification of the affected area on a blade.**

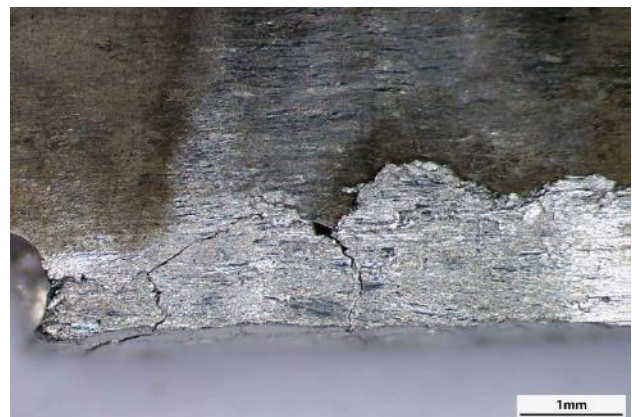
**Figure 4. A higher magnification of the affected area on a blade.**

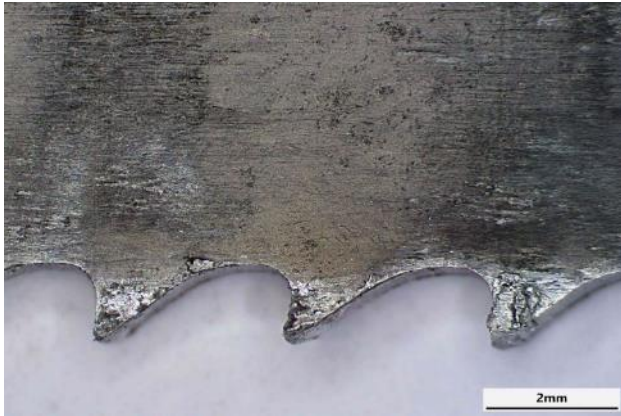
An attempt to push the aluminium alloy off the blade, using a needle point file, proved to be successful, with some force, as shown in Figure 5. The aluminium alloy appeared to have cold welded onto the sides of the teeth. Figure 6 shows three of the released aluminium alloy fragments lined up to mimic the pattern of the teeth from which they were liberated.

**Figure 5. The teeth from which most of the aluminium alloy was removed.**

The aluminium alloy did not cut very well. Instead, it adhered to the blade and clogged up the gaps between the teeth, thereby making it impossible for the blade to cut. Removal of the aluminium alloy from the teeth revealed that the teeth were not damaged and were, indeed, still sharp.

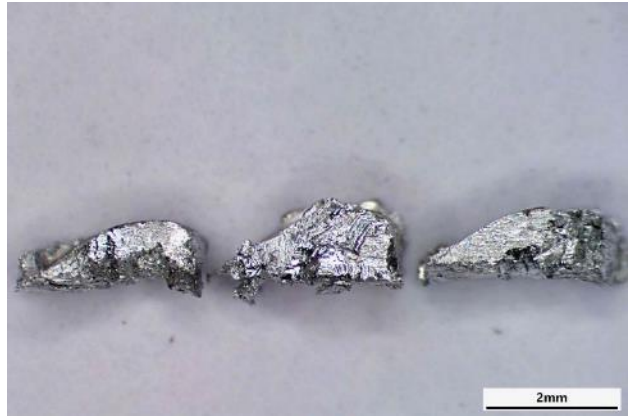
**Figure 6. Some bits of aluminium alloy removed from the teeth.**

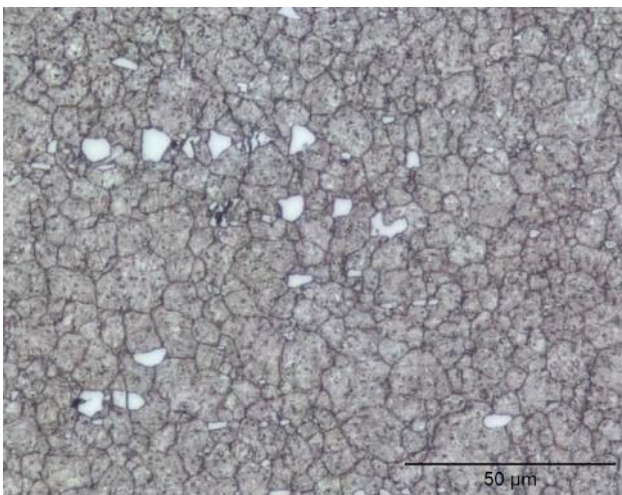
Examination of a metallographically prepared section from one of the blades revealed very fine grains of tempered martensite with randomly dispersed primary carbides, typical of high speed tool steel. No irregularities were observed. A photomicrograph is shown in Figure 7.

**Figure 7. High magnification photomicrograph of the jigsaw blade's microstructure.**
